CETOL 6σ HEAVY INDUSTRY STUDY

Root Cause Analysis with CETOL 6σ Eliminates the Guessing

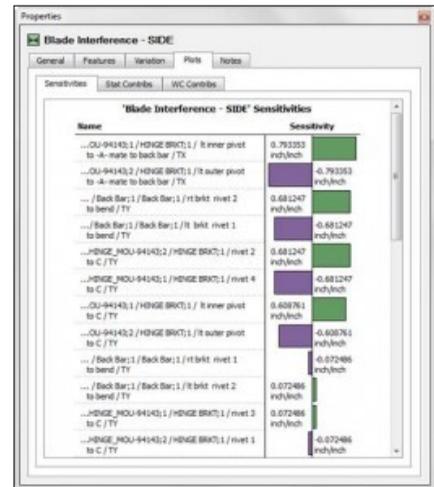
By ranking sensitivity data in Pareto fashion, users of CETOL 6σ can quickly identify what areas of the assembly to investigate. For the data on the right, it makes sense to begin investigating the top eight sensitivities since the next highest sensitivity is approximately 9 times smaller. Our customer is able to identify the true root cause issue more quickly and accurately, thus minimizing several important considerations including downtime for the customer, cost of repair, and avoidance of future warranty claims.

Name	Sensitivity
.../OU-94343/1/HNGE BRKT/1 / Rivet pivot to -A- mate to back bar / TY	0.793253 ind/inch
.../OU-94343/2/HNGE BRKT/1 /R outer pivot to -A- mate to back bar / TY	0.793253 ind/inch
... / Back Bar/1 / Back Bar/1 / Rivet rivet 2 to bend / TY	0.681247 ind/inch
... / Back Bar/1 / Back Bar/1 / Rivet rivet 1 to bend / TY	0.681247 ind/inch
.../HNGE_MDU-94343/2 /HNGE BRKT/1 / rivet 2 to C / TY	0.681247 ind/inch
.../HNGE_MDU-94343/1 /HNGE BRKT/1 / rivet 4 to C / TY	0.681247 ind/inch
.../OU-94343/1 /HNGE BRKT/1 / Rivet pivot to C / TY	0.608761 ind/inch
.../OU-94343/2 /HNGE BRKT/1 /R outer pivot to C / TY	0.608761 ind/inch
... / Back Bar/1 / Back Bar/1 / Rivet rivet 1 to bend / TY	0.072486 ind/inch
... / Back Bar/1 / Back Bar/1 / Rivet rivet 2 to bend / TY	0.072486 ind/inch
.../HNGE_MDU-94343/1 /HNGE BRKT/1 / rivet 3 to C / TY	0.072486 ind/inch
.../HNGE_MDU-94343/2 /HNGE BRKT/1 / rivet 1 to C / TY	0.072486 ind/inch
